FOREST PRODUCTS RESEARCH IN PICTURES

NO. 43

# ERECTING TEST FENCE FOR WOOD PAINTING STUDY

FOREST PRODUCTS LABORATORY  
U. S. FOREST SERVICE  
MADISON, WISCONSIN

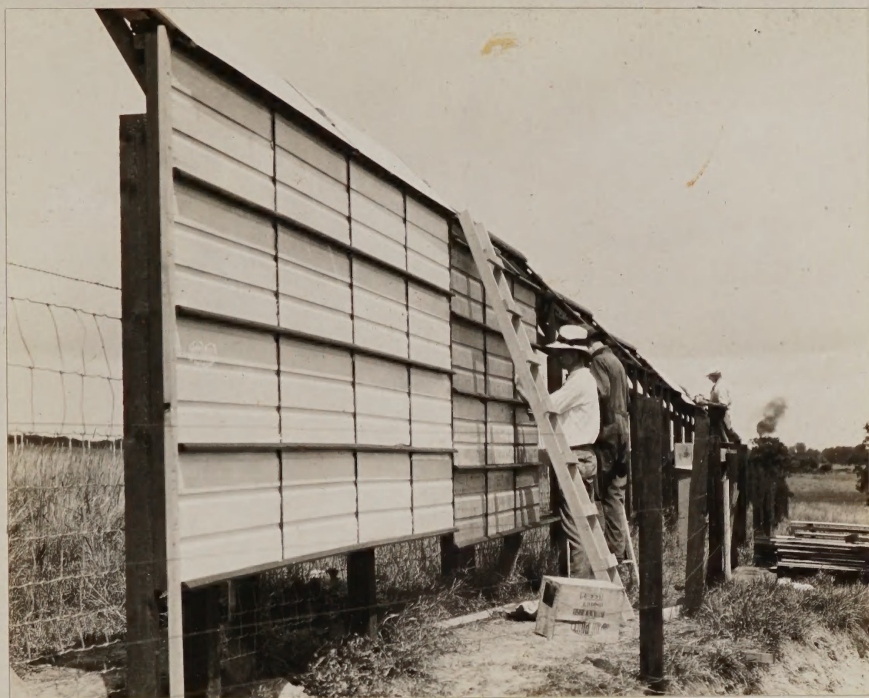
This test fence is being erected by the Forest Products Laboratory at Madison, Wisconsin, to show which of the woods commonly used in outside construction will take and hold paint satisfactorily, which are difficult to paint, and how painting difficulties may be overcome. Nine other test fences are being put up in the various climatic regions of the United States.

A flat-grain panel and an edge-grain panel of each kind of wood are coated with each kind of paint. Three coats of the paints are applied. The row of tilted panels at the top of the fence is for the purpose of comparing weathering of paint on an inclined surface with weathering on the vertical surfaces.

Horizontal drain strips between panels serve to keep the pigment of the upper panels from washing across the lower ones.

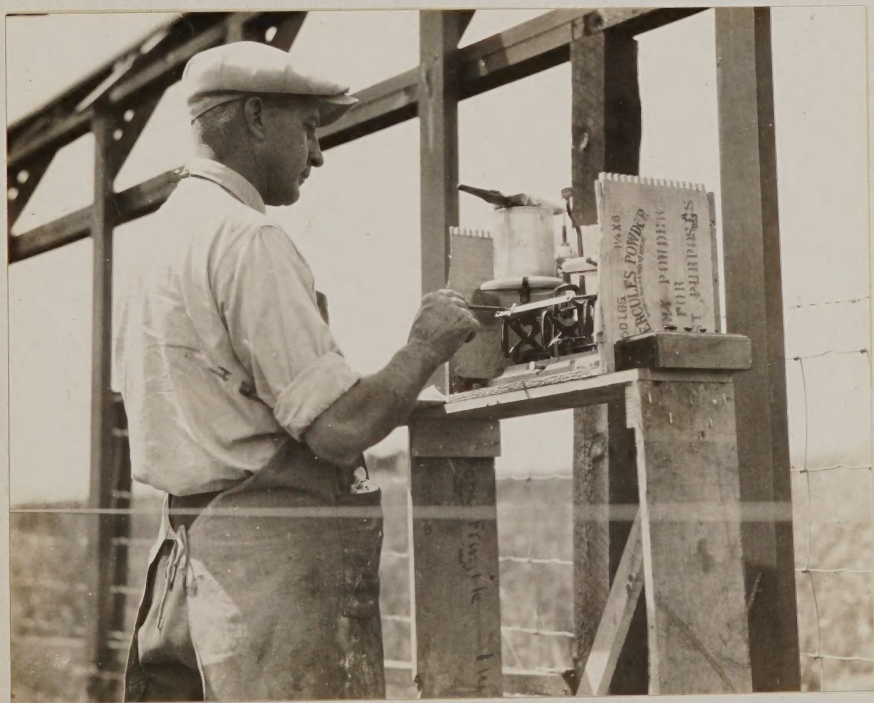
After each coat of paint is applied to a panel, the painter weighs paint, can, and brush, as shown in the lower photograph, to determine the amount of paint required to coat the various woods.
